Arborist Associates Ltd.

An Arboricultural Assessment of the Tree Vegetation on a Development site at 'Wayside', Enniskerry Road and Glenamuck Road, Kilternan, Dublin 18. (Stage 3 of the LRD Application)

Prepared for: Liscove Limited.

Date: 17th June 2024

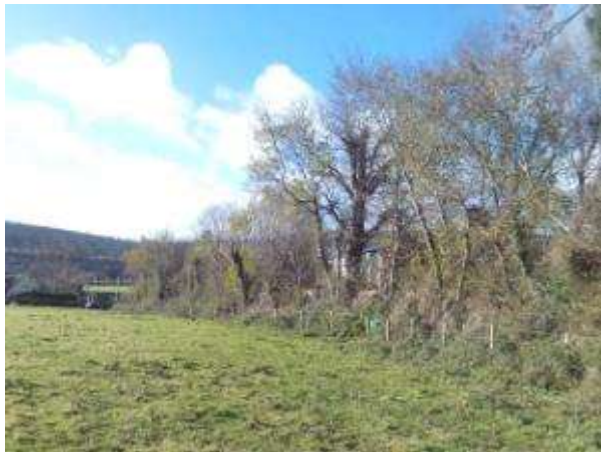
The following trees are located within Hedge No.1.									
601	Sycamore <i>Acer pseudoplatanus</i>	7	120	1N 0.5S 1E 1W	1.8	Young	Good	Fair It is a single stem tree that has self-seeded into this area. It is developing along the hedge line and it has potential to form part of the long-term cover of the site.	Clear Bramble and scrub from around its base.	20-40	C2

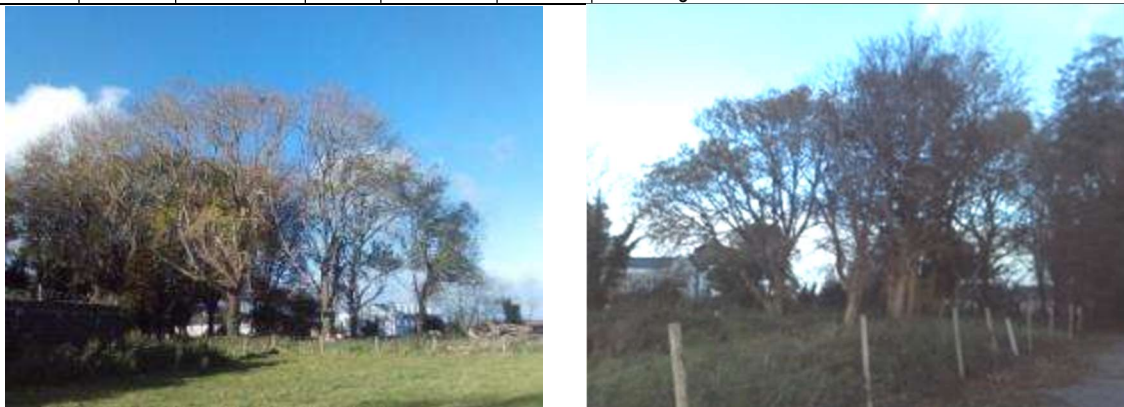
The following is a breakdown of this group of trees.											
629	Ash <i>Fraxinus excelsior</i>	18	770	7N 8S 7E 9W	4	Mature	Fair	Fair It is a large prominent tree with a broad crown formation. It contains deadwood throughout its crown and the heavy Ivy cover on the main trunk has been cut at ground level. Its crown is showing early signs of infection by ‘Ash Dieback’ (<i>Hymenoscyphus fraxineus</i>).	Remove dead/ unstable growth. Monitor condition particularly for decline due to ‘Ash Dieback’ and manage accordingly.	10+	C2
		The following trees (Nos. 630 – 634& 653) make up part of the one group canopy formation. Some of these trees are reliant on one another for support/shelter and this will need to be taken into consideration during their management.								---	B2

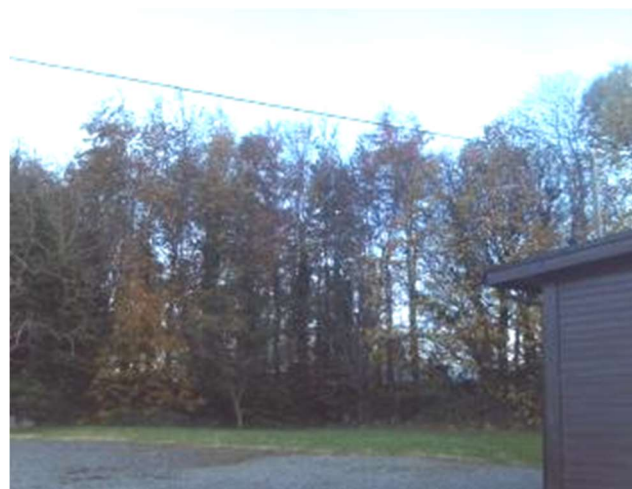
The following trees have been incorporated into the woodland block.

Tree No.	Tree Species	Ht.(m)	Stem Dia. (mm)	Branch Spread(m)	C-Ht. (m)	Age Class	Phys. Con.	Structural Condition Other Comments	Preliminary Recommendation	Years Estimate	Cat. Grade
								N-north S-south E-east W- west Phys.-physiological Ht.- Height C-Ht.- Crown	A- average Cat.- Category		
1303	Sycamore <i>Acer pseudoplatanus</i>	15	500 400 450 320 350	5N 6S 6E 5W	2	Mature	Fair	Fair / Poor It is a large multiple-stemmed tree from base growing against the boundary wall with the neighbouring property and may have suffered some root damage during construction of the boundary wall. Basal decay is present with suckers growing from its base. It forms part of the Woodland Block No.1 and is of some value to the group structure.	Tidy up the undergrowth to allow a more detailed assessment of its base and lower trunk.	10-20	C2
1304	Ash <i>Fraxinus excelsior</i>	14	280	3N 2S 2E 3W	1	Early Mature	Fair/ Poor	Fair/Poor It forms part of the group canopy formation of this woodland block. It is showing signs of decline/ dieback throughout its crown due to infection by 'Ash Dieback'. It is beginning to be suppressed by Ivy and is not integral to the overall group canopy structure of this woodland.	I would recommend its removal as part of management.	<10	U

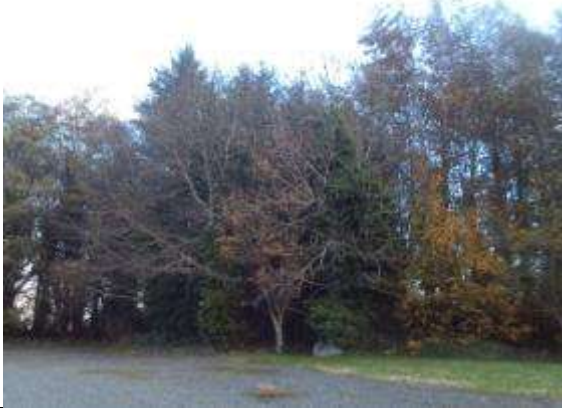
Tree No.	Tree Species	Ht.(m)	Stem Dia. (mm)	Branch Spread(m)	C- Ht. (m)	Age Class	Phys. Con.	Structural Condition Other Comments	Preliminary Recommendation	Years Estimate	Cat. Grade
								N-north S-south E-east W- west Phys.-physiological Ht.- Height C-Ht.- Crown	A- average Cat.- Category		
								result. The lower branches have been pruned/ removed previously in order to raise up its crown. It may have been damaged during the construction of the boundary wall. It has been inter-grated into Woodland Block No. 1 and is not integral to the overall group canopy structure.	(<i>Hymenoscyphus fraxineus</i>) and manage accordingly.		
Woodland Block No.2	Norway Spruce <i>Picea abies</i> Ash <i>Fraxinus excelsior</i>	A16	A350	A3N 3S 3E 3W	A1. 5	Early Mature	Fair	Fair It is located to the east of Woodland Block No.1 and consists of predominately Norway Spruce with some Ash trees developing throughout. These trees have been planted at close spacing to one another and they are growing up together forming tall, top-heavy trees. Some openings have developed within the woodland canopy as a result of tree failure. A lot of the Ash trees are showing signs of infection by 'Ash Dieback' (<i>Hymenoscyphus fraxineus</i>).

Make safe large size dead/ unstable growth. Cut Ivy at ground level where it is heavy on trees.	20+	C2

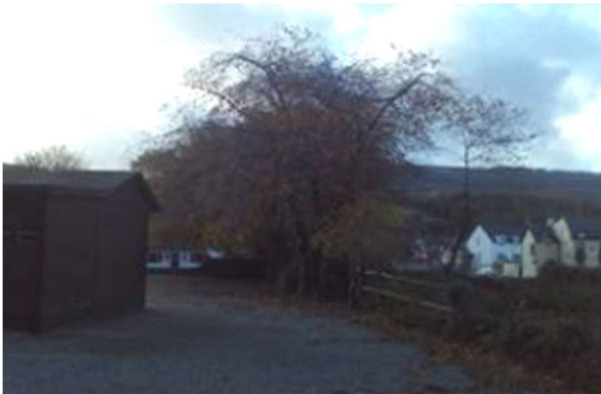
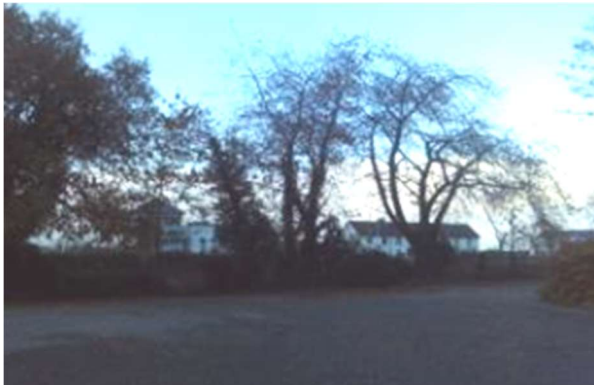
The following trees are located along the northern boundary of the County Market Grounds and borders onto the wasteland. <div>

Tree No.	Tree Species	Ht.(m)	Stem Dia. (mm)	Branch Spread(m)	C-Ht. (m)	Age Class	Phys. Con.	Structural Condition Other Comments	Preliminary Recommendation	Years Estimate	Cat. Grade
								N-north S-south E-east W- west Phys.-physiological Ht.- Height C-Ht.- Crown	A- average Cat.- Category		
1310	Flowering Cherry <i>Prunus avium</i>	13	750	5N 6S 6E 4W	2	Mature	Fair	Fair It is a large size tree with a broad spreading crown formation. The lower limbs/ branches have been removed previously or have been cut back to raise up its crown. The surfacing around its base may have caused some soil and root damage. It is infected at its base by the fungus " <i>Pholiota schweinitzii</i> " and contains deadwood within its crown. The Ivy cover on the main trunk had been cut previously, but is beginning to re-establish.	Remove dead/ unstable growth. Re-cut Ivy at ground level. Monitor its condition.	10+	C2
1311	Flowering Cherry <i>Prunus avium</i>	13	300 300 280 110	5N 5S 3E 4W	3	Mature	Fair	Fair It is a large size, multiple-stemmed tree from low down with an acute union formation between stems. The lower branches have been pruned/ cut back previously in order to raise up its crown. It forms part of the group canopy formation with the neighbouring trees. The Ivy cover on the main trunk had been cut previously, but is beginning to re-establish.	Make safe any dead/ unstable growth. Re-cut Ivy at ground level.	10-20	C2

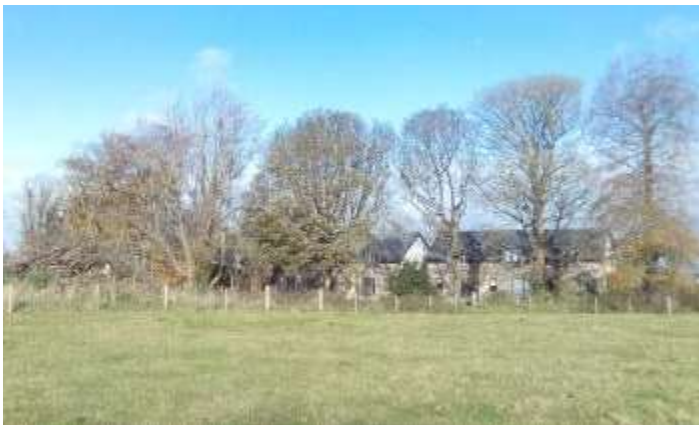
Tree No.	Tree Species	Ht.(m)	Stem Dia. (mm)	Branch Spread(m)	C-Ht. (m)	Age Class	Phys. Con.	Structural Condition Other Comments	Preliminary Recommendation	Years Estimate	Cat. Grade
								N-north S-south E-east W- west Phys.-physiological Ht.- Height C-Ht.- Crown	A- average Cat.- Category		
	<i>Sambucus nigra</i> Hawthorn <i>Crataegus monogyna</i> Bramble <i>Rubus fruticosus</i> Dogrose <i>Rosa canina</i> Elm <i>Ulmus glabra</i> Ash <i>Fraxinus excelsior</i> Sycamore <i>Acer pseudoplatanus</i>	<p>It is a prominent/visual group of trees of value to the treescape/sylvan character of the area. Some of the trees within this group are growing within a sheltered group environment and depend on one another for support / shelter and this will need to be taken into consideration during their management.</p> <p>There is an undergrowth of pockets of Holly, Elder, Hawthorn, Bramble and Dogrose with some natural re-generation of Elm, Ash and Sycamore developing up through it also.</p>

Trees growing up within sheltered group environments will need to be maintained /managed within this environment.

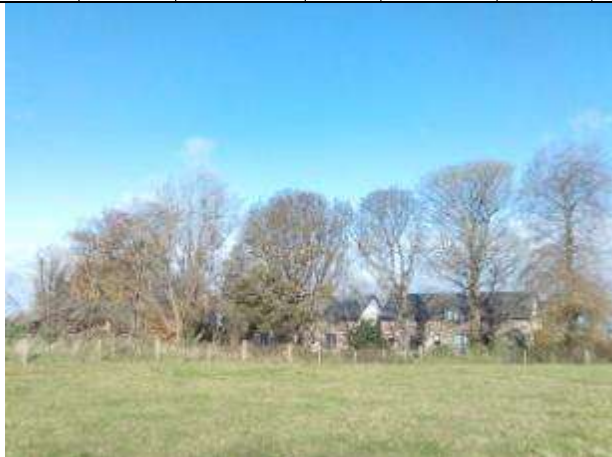
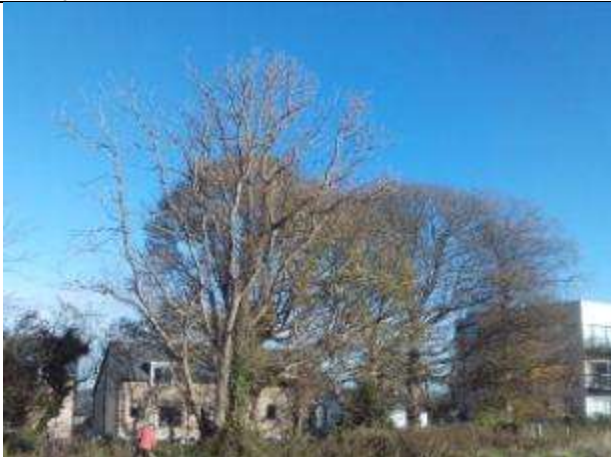
The following trees are located along the back of the boundary wall with the recently constructed houses which are in close proximity.									
673	Ash <i>Fraxinus excelsior</i>	6	140	3N 3S 1E 12W	2	Young	Fair	Fair A single stem tree growing up under the canopy of the larger Tree No. 674 to the south and the crown is somewhat suppressed as a result. It may succumb to ‘Ash Dieback’.	Requires no work at the present time. Monitor condition particularly for signs of ‘Ash Dieback’ and monitor accordingly.	10+	C1
674	Ash <i>Fraxinus excelsior</i>	15	670 210 630	8N 8S 8E 10W	2	Mature	Fair/ Poor	Fair/Poor Twin-stemmed from base with a slightly acute union formation between stems. It has a slightly asymmetrical crown due to overcrowding by a neighbouring tree. The soil levels would appear to have been raised slightly around its base with rubble being pushed into this area. Heavy Ivy cover was extending up into the crown and this has been cut at ground level. It is infected by ‘Bacteria Canker of Ash’ and	Remove dead/unstable growth. Monitor condition particularly for signs of ‘Ash Dieback’ and monitor accordingly.	10+	C2

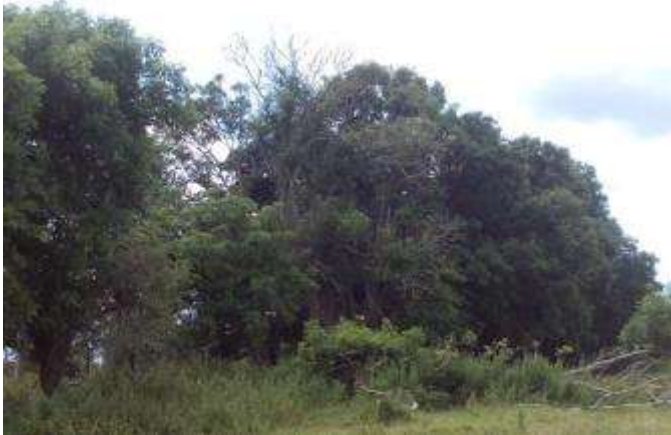
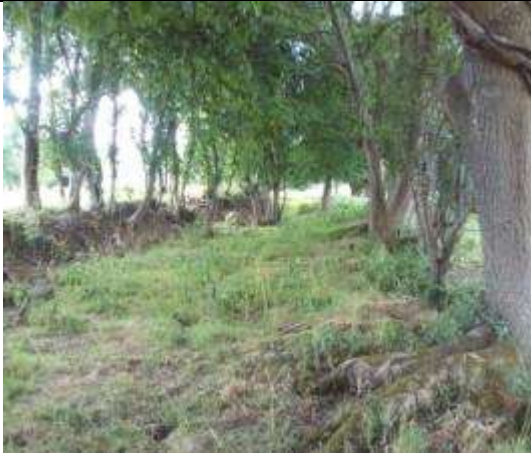
</div> <p>The following trees are located within Tree Belt No.1. working from east to west.</p>									
687	Ash <i>Fraxinus excelsior</i>	7	8 stems 180 170 150 160 340 250 240 160	3N 3S 3E 2W	1	Mature	Fair	Poor It is multiple-stemmed from base as a result of being cut down in the past and has since been cut again at to maintain clearance with overhead power lines.	It will require ongoing pruning to contain in this position under the power lines. I would recommend its removal as the most appropriate management option.	<10	U
688	Hawthorn <i>Crataegus monogyna</i>	8	390 300	4N 2S 4E 3W	2	Mature	Fair/ Poor	Poor Heavy Ivy cover suppressing the crown has been cut at ground level. It is part of the remains of an old hedgerow and forms part of the lower bulking.	Remove deadwood and unstable growth.	10+	C2

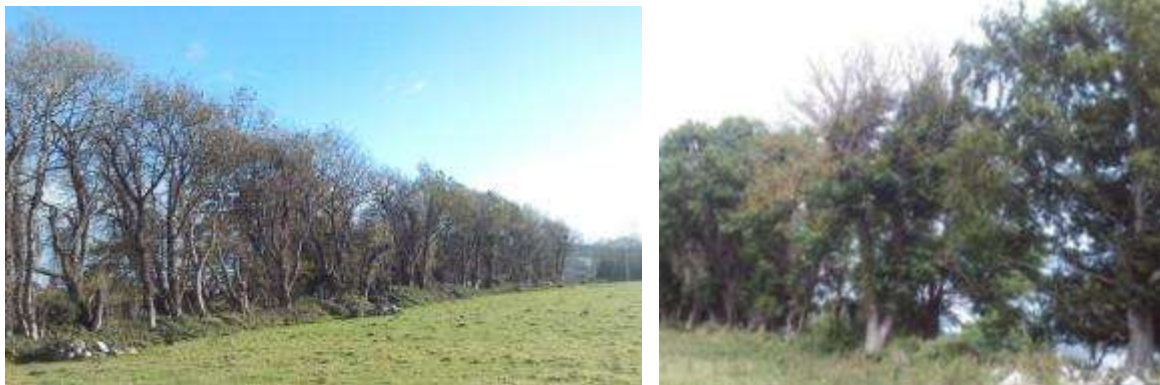
by 'Ash Dieback'. The Elm tree population for 'Dutch Elm Disease' and manage accordingly. This will see some of these trees needing to be removed as part of management in the short term.			
		The following trees are located within Tree Belt No.2. I have broken up this tree belt into smaller tree lines/groups based on where natural breaks within the canopy line have occurred. These breaks within the tree line have occurred mainly as a result of trees failing partially / completely or by being removed during past management works.

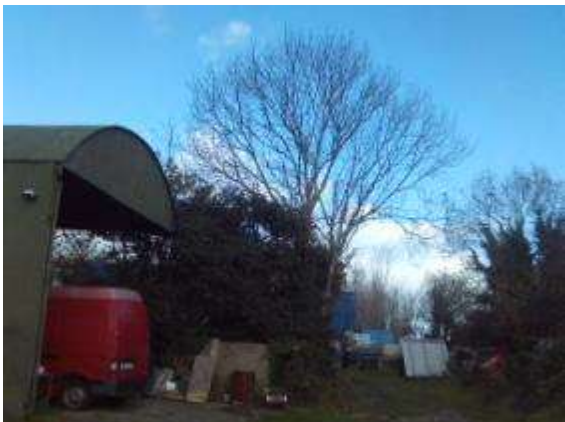
create a more continuous hedge.		
547	Ash <i>Fraxinus excelsior</i>	17	360/ 380	6N 7S 8E 7W	2	Mature	Fair	Fair It is a large prominent tree that is multiple-stemmed from base. Heavy Ivy cover is extending into its crown causing suppression and there is some deadwood in its crown with early signs of infection by 'Ash Dieback' (<i>Hymenoscyphus fraxineus</i>). Dense undergrowth is limiting the visual assessment of its base and lower trunk.	Remove undergrowth and lower Ivy to 2m to allow a more detailed assessment.	10+	C1

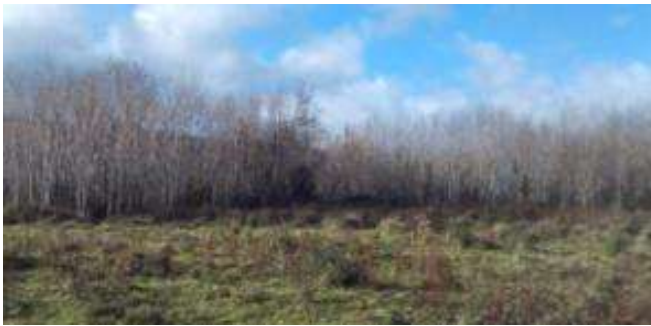
Tree No.	Tree Species	Ht.(m)	Stem Dia. (mm)	Branch Spread(m)	C-Ht. (m)	Age Class	Phys. Con.	Structural Condition Other Comments	Preliminary Recommendation	Years Estimate	Cat. Grade
								N-north S-south E-east W- west Phys.-physiological Ht.- Height C-Ht.- Crown	A- average Cat.- Category		
								being suppressed by Ivy. Its crown is showing signs of infection by 'Ash Dieback'.	allow a more detailed assessment of base.		
548	Ash <i>Fraxinus excelsior</i>	13	300/ 300	5N 5S 5E 5W	4	Mature	Fair/ Poor	Poor It is located on the east side of the stone bank and is twin-stemmed from base with an acute union formation between stems. Root damage caused on its south side will impact on its health and stability. Its crown is showing some decline due to infection by 'Ash Dieback' and possibly some root damage.	I would recommend its removal as part of management.	<10	U
Scrub/ Nursery Stock	Ash <i>Fraxinus excelsior</i> Sycamore <i>Acer pseudoplatanus</i>	--	--	--	--	Semi Mature	Fair	Fair It consists of a large area, mainly between Hedge No.6 & 7. It would appear to have been nursery stock which was planted out and allowed to grow unmanaged with a dense undergrowth of Bramble. A lot of the Ash showing infection by 'Ash Dieback' and this will limit their potential.

Tidy up undergrowth and carry out selective thinning to reduce density and competition and allow the better quality trees space to develop.	10+	C1

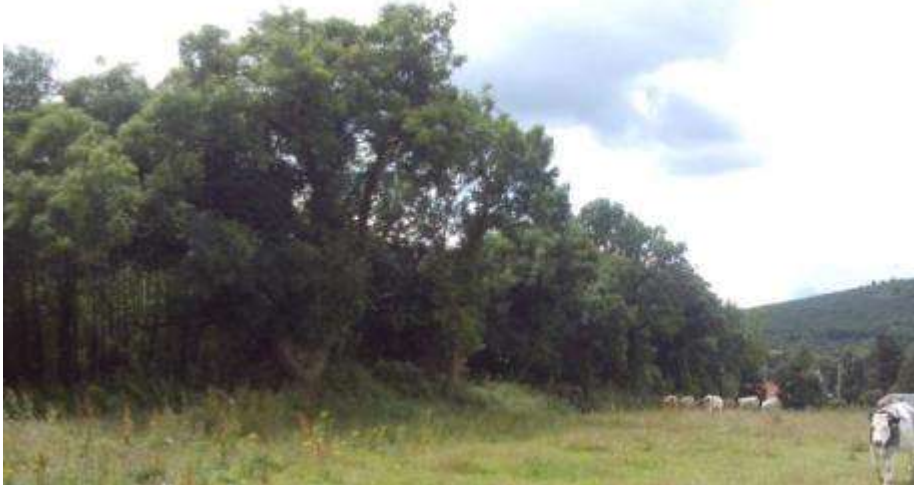
872 + 873	Ash <i>Fraxinus excelsior</i>	12 12	250 300 280 300	3N 5S 6E 2W	1 2	Mature	Fair	Fair It consists of two trees growing up together to form part of the one canopy formation. They form a reasonably symmetrical canopy formation and are multiple-stemmed from base. Heavy Ivy cover on their main stems is extending up into their crowns and they contain deadwood throughout. It is showing little sign of infection by 'Ash Dieback' at present. There is wire attached to their lower trunks. Tree No. 872 has been heavily cut back on the north side and the lower crown has been removed. One of the stems has also been cut back.	Remove dead/ unstable growth and cut Ivy at ground level They would benefit from a more detailed assessment.	10-20	C2
