***Quality Audit including
a Road Safety Audit,
DMURS Street Design
Audit, Cycle Audit, Walking
Audit, and an Access
Audit.***

Kilternan Village LRD

***Kilternan,
Co. Dublin***

SUBMISSION ISSUE

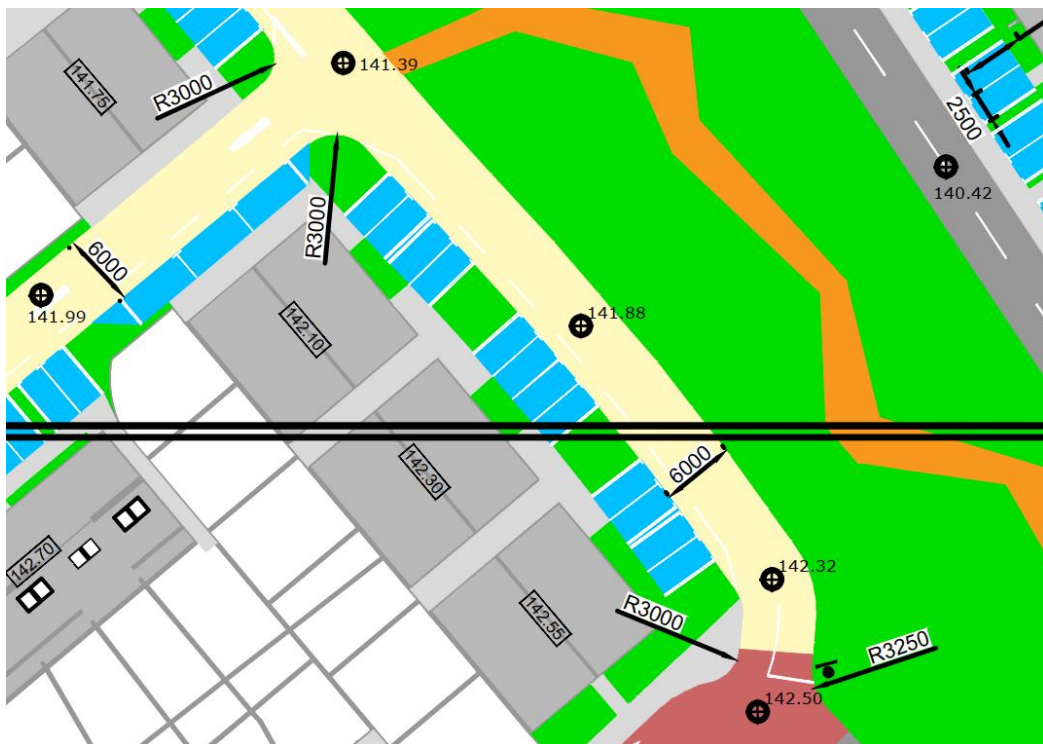
Figure 3.1 – Street 5

Street 5 Road Carriageway Width / Dwg no. 900705 GENERAL ROAD LAYOUT

Street 5 is shown as a 6.0m wide road carriageway. Dashed lines are shown, which are presumed to indicate a pedestrian path / refuge. While it may be intended to provide contrasting materials (which are important tools for informing drivers of driving conditions) compared to a typical bitumen road surface, it is noted that narrow carriageways are one of the most effective design measures that calm traffic. The 6.0m wide road carriageway will likely encourage motorists to drive at excessive speeds, which may result in a collision with a pedestrian or cyclists using the road.

Shared surface streets can be very intimidating for visually or mobility impaired road users.

The road width should be reduced to a **maximum of 4.8m in width consistent with DMURS**. Verges (which can be a hard landscaping) should be provided that act as refuge zones allowing pedestrians (in particular for visually or mobility impaired road users) to step on and off the carriageway to let cars pass. These verges should be 1.2m minimum, thus allowing for the appropriate width for cars turning from perpendicular parking.

3.1	Y	N	The design accords with DMURS. The street has a 4.8m carriageway with a 1.2m pedestrian comfort strip. This is delineated by a dashed line in the drawings. In -situ the design will incorporate different material finished that will further reinforce the shared nature of the surface.	Y

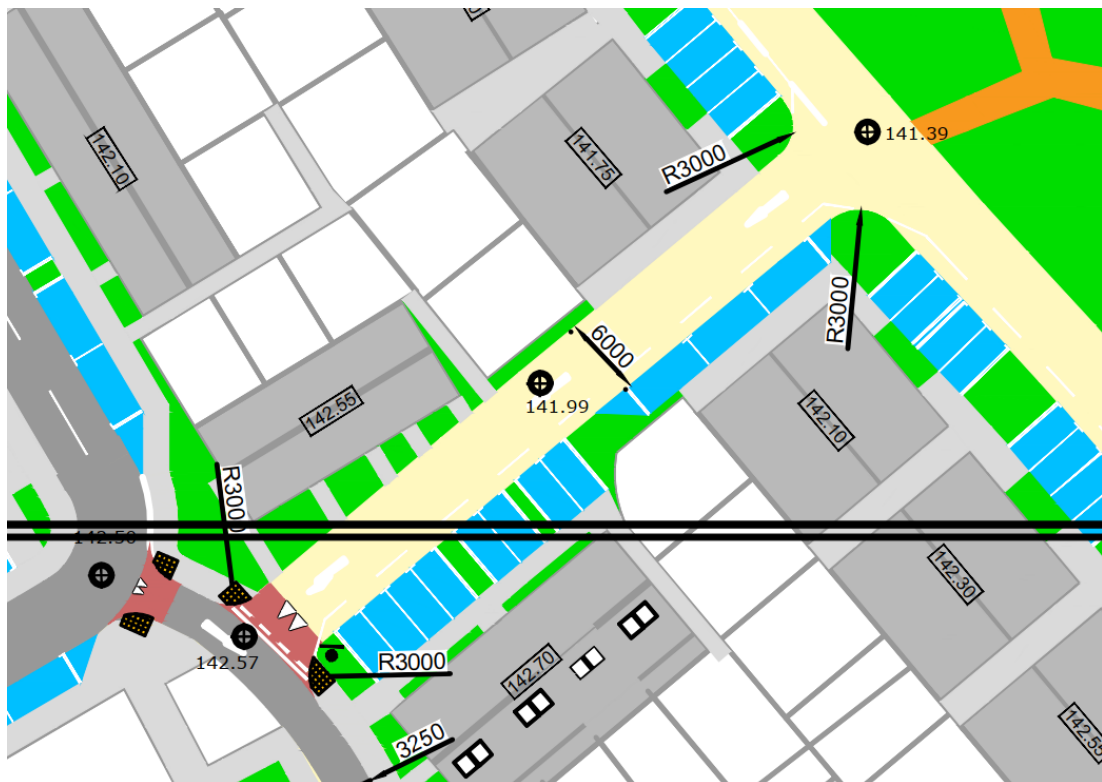
Figure 3.2 – Street 3

Street 3 Road Carriageway Width / Dwg no. 900705 GENERAL ROAD LAYOUT

Street 3 is shown as a 6.0m wide, one-way road carriageway. Dashed lines are shown, which are presumed to indicate a pedestrian path / refuge. While it may be intended to provide contrasting materials (which are important tools for informing drivers of driving conditions) compared to a typical bitumen road surface, it is noted that narrow carriageways are one of the most effective design measures that calm traffic. The 6.0m wide road carriageway will likely encourage motorists to drive at excessive speeds, which may result in a collision with a pedestrian or cyclists using the road.

Shared surface streets can be very intimidating for visually or mobility impaired road users.

The road width should be reduced to **a maximum of 4.8m in width**. Verges (which can be hard landscaping) should be provided that act as refuge zones allowing pedestrians (in particular for visually or mobility impaired road users) to step on and off the carriageway to let cars pass. These verges should be 1.2m minimum, thus allowing for the appropriate width for cars turning from perpendicular parking.

3.2	Y	N	Vehicle tracking and movement has dictated that this short street section is design as shown. Space is required for larger vehicles to access and fpr so perpendicular cars to access / egress car parking space. The street. Changes shared street is design for very low speeds and very low volumes and the shared space will act as a part of the social aspect of the community fostering play etc.	Y

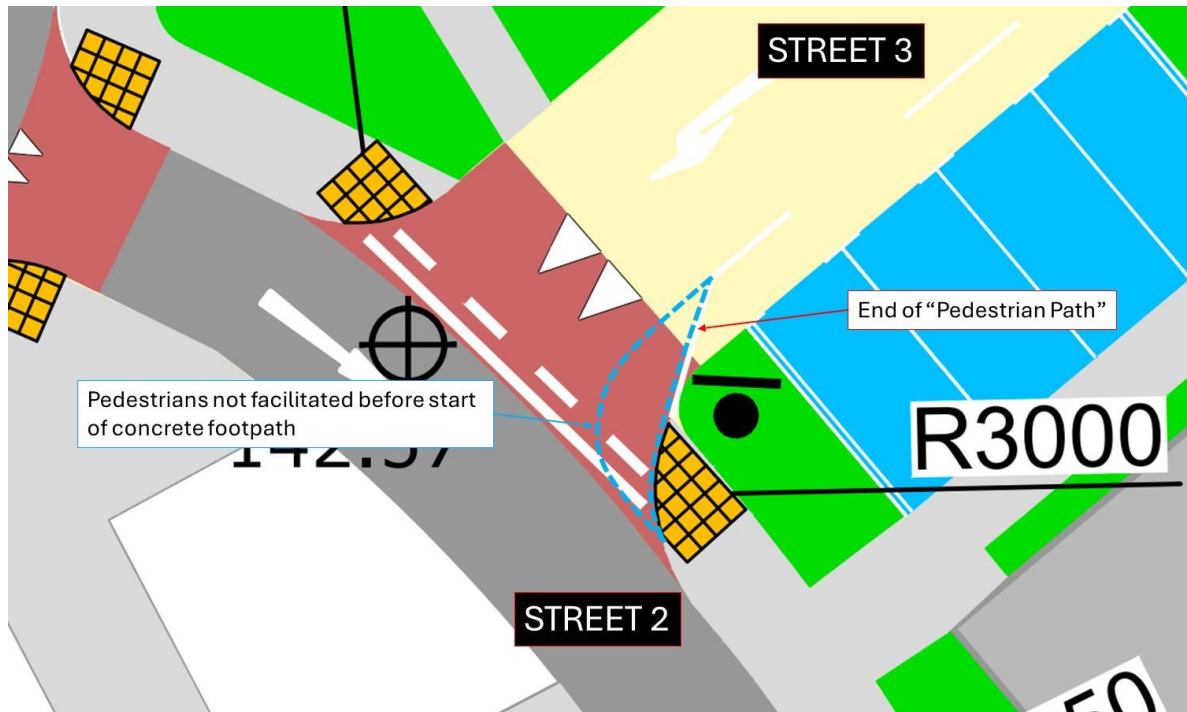
Figure 3.3 – Junction Street 3 - Street 2

Street 3 - Street 2 Junction / Dwg no. 900705 GENERAL ROAD LAYOUT

The 'Pedestrian Path' on Street 3, ends before the junction with Street 2. Pedestrians will be vulnerable to vehicles, in particular fast moving vehicles, turning left from Street 3. Furthermore, the radius appears larger than 3m.

The footpath on Street 2 should be extended back onto Street 3, so that pedestrians are not vulnerable to vehicles which are turning left from Street 3 onto Street 2.

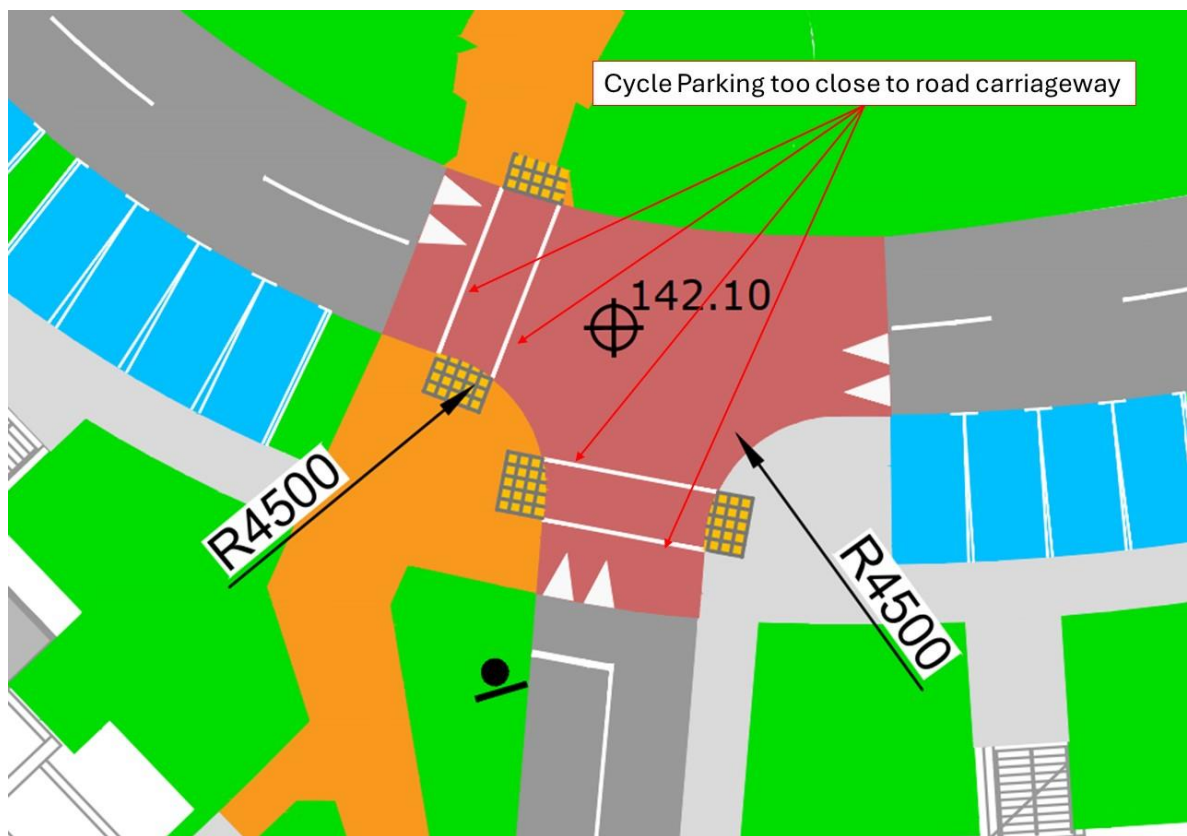
Figure 3.4 – Solid White Lines at Uncontrolled Crossings

Throughout the Scheme / Dwg no. 900705 GENERAL ROAD LAYOUT

Solid white lines are shown on all uncontrolled pedestrian crossings throughout the scheme. But as these are uncontrolled crossings, solid white lines should not be provided, as motorists have priority. The solid white lines may lead to confusion as to who has priority, with pedestrians stepping out onto the road carriageway when there is not a safe gap in the traffic, leading to a collision. The change in material and vertical deflection should mean that the crossings act as Courtesy crossings, which allow pedestrians to informally assert a degree of priority over drivers

The solid white lines should be removed.

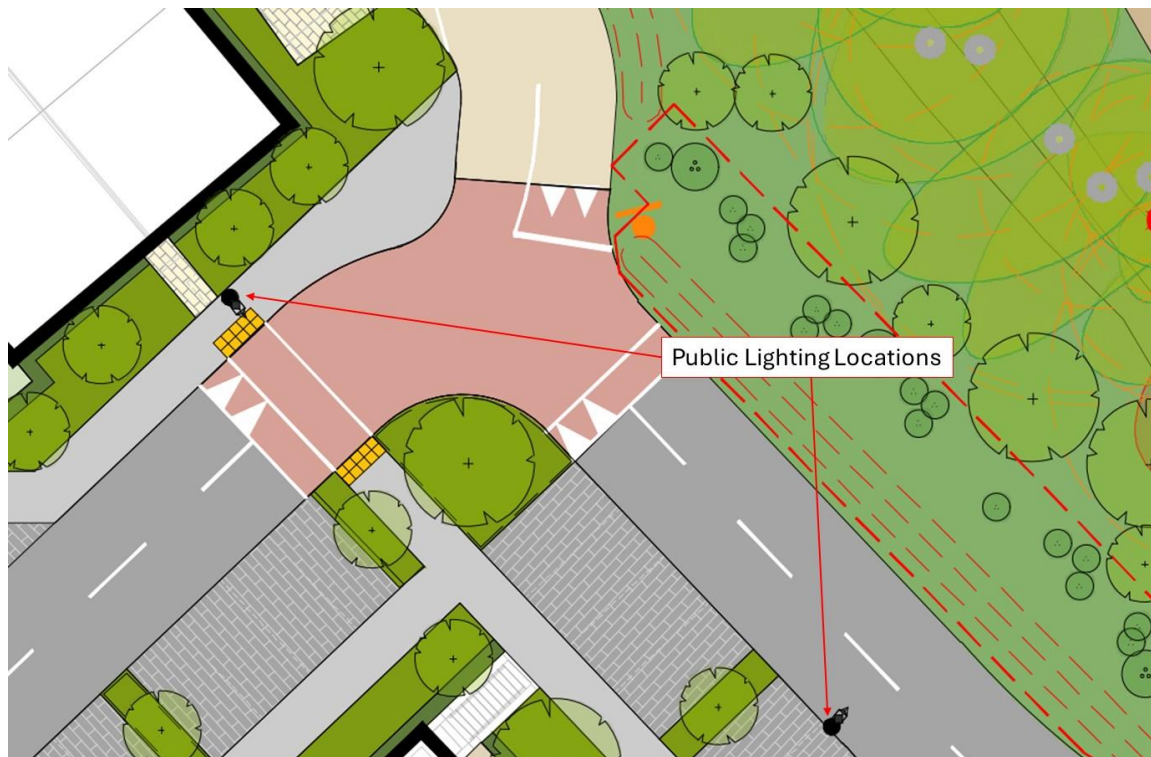
Figure 3.5 – Public Lighting Locations

Throughout the Scheme / Dwg no. L1_100_GENERAL ARRANGEMENT PLAN

The Public Lighting are shown in locations where they will both obstruct both pedestrian and vehicle movements, which could lead collision with the poles resulting in injury.

A review of Public Lighting locations should be undertaken. Ideally, the public lighting is set back off the pedestrian footpaths and therefore not obstructing pedestrian movement.

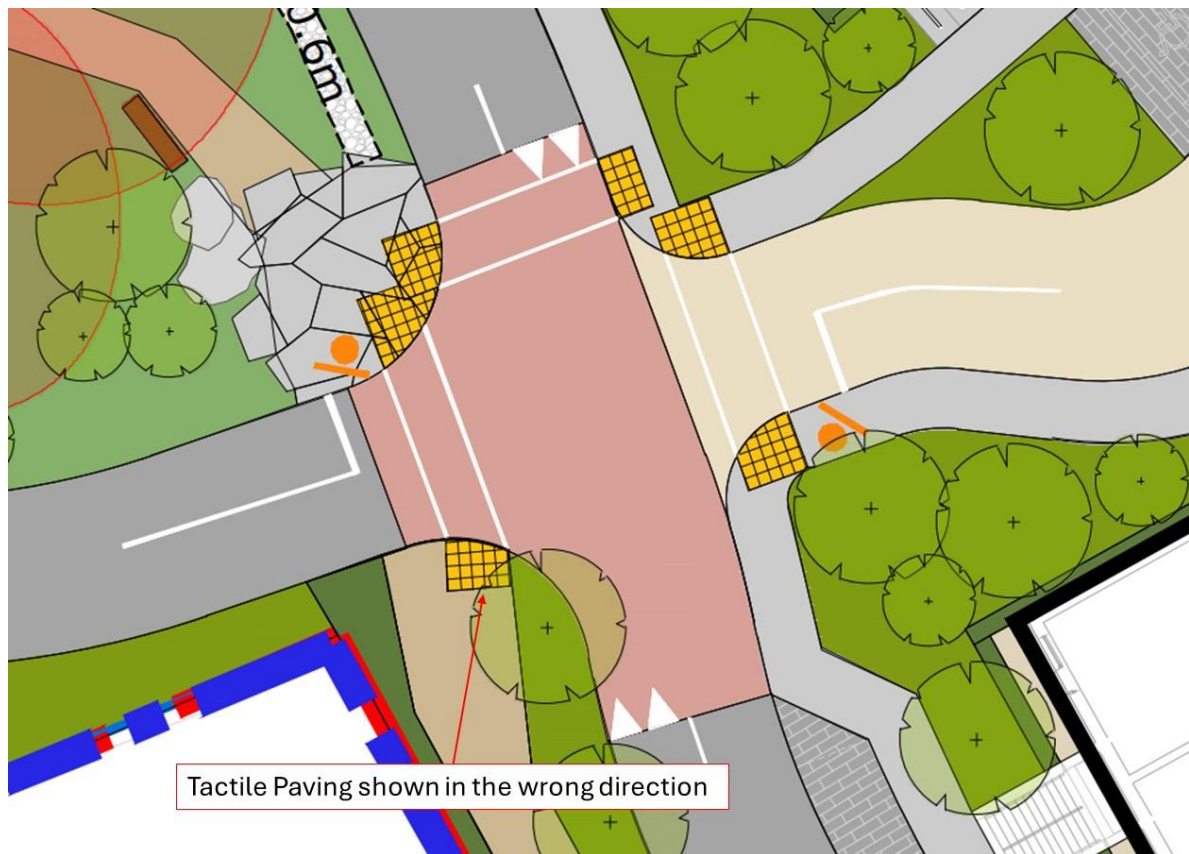
Figure 3.6 – Tactile Paving

Some of the tactile paving is not orientated in the correct direction. Visually impaired people use the orientation of the tactile paving to align themselves correctly before crossing the road. Incorrectly aligned tactile paving will direct people out onto the junction, which could result in a collision between a pedestrian and vehicle.

All the tactile paving through the scheme should be designed in accordance with the “*Guidance on the Use of Tactile Paving Surfaces*”. The back edge of the tactile surface should be at right angles to the direction of crossing.

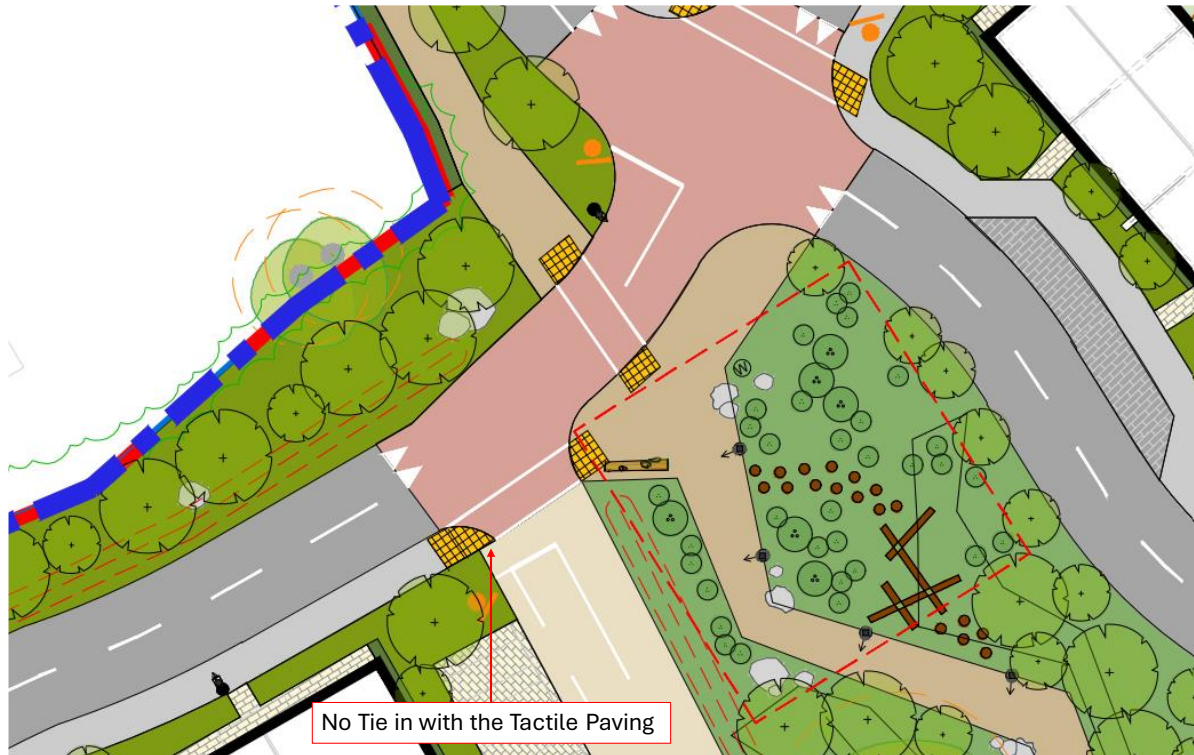
Figure 3.7 – No Tie-In with Tactile Paving

Proposed T-Junction / Dwg no. L1_100_GENERAL ARRANGEMENT PLAN

There are no tie-ins with the on-road pedestrian refuge and the tactile paving, with a stop line extending across the pedestrian refuge, resulting in a kerb protruding into the junction which could be a hazard for vehicles.

An appropriate tie-in should be provided.

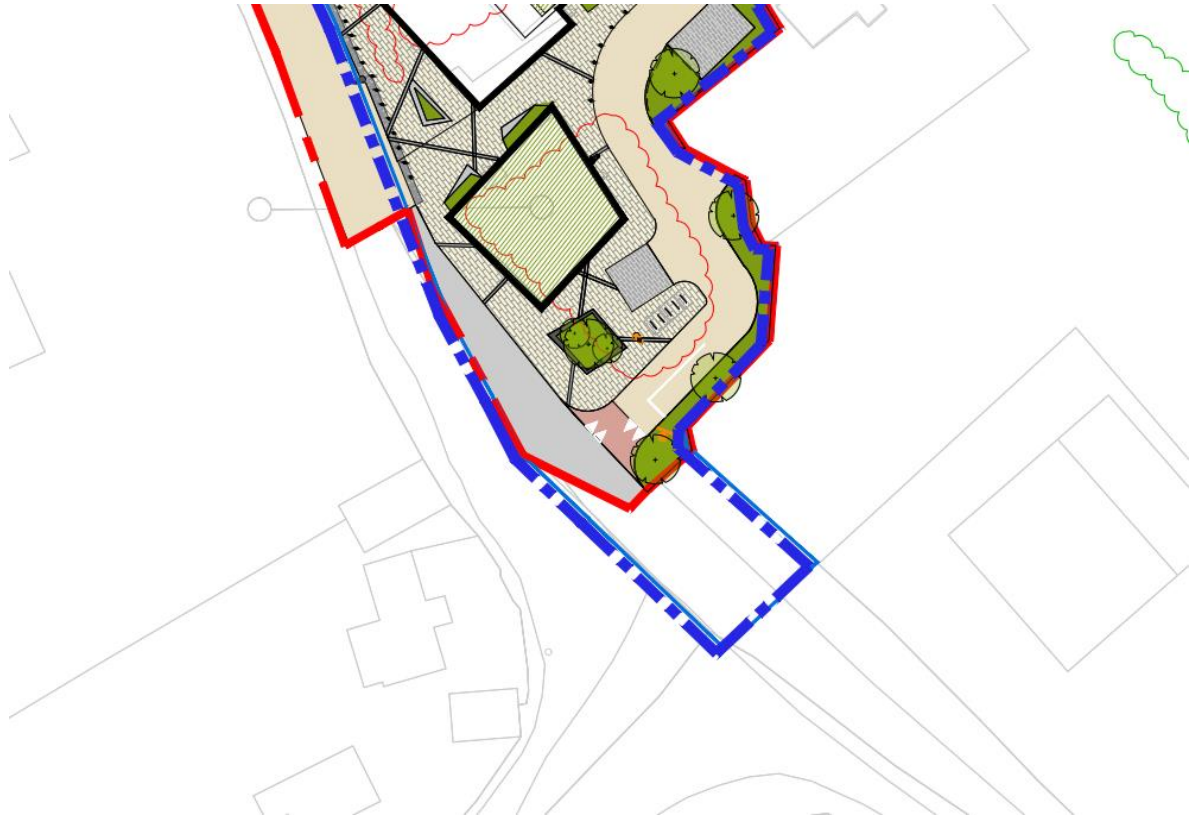
Figure 3.8 – Enniskerry Road Southern Access

Enniskerry Road Southern Access / Dwg no. L1_100_GENERAL ARRANGEMENT PLAN

A tree has been provided to the left of the access, while there is a building close to the road edge, which may impede the exit visibility and result in vehicles exiting when it is unsafe to do so resulting in a side impact collision.

Ensure that appropriate exit visibility is provided. While slim objects such as signs, public lighting columns and street trees may be provided, designers should be aware of their cumulative impact.

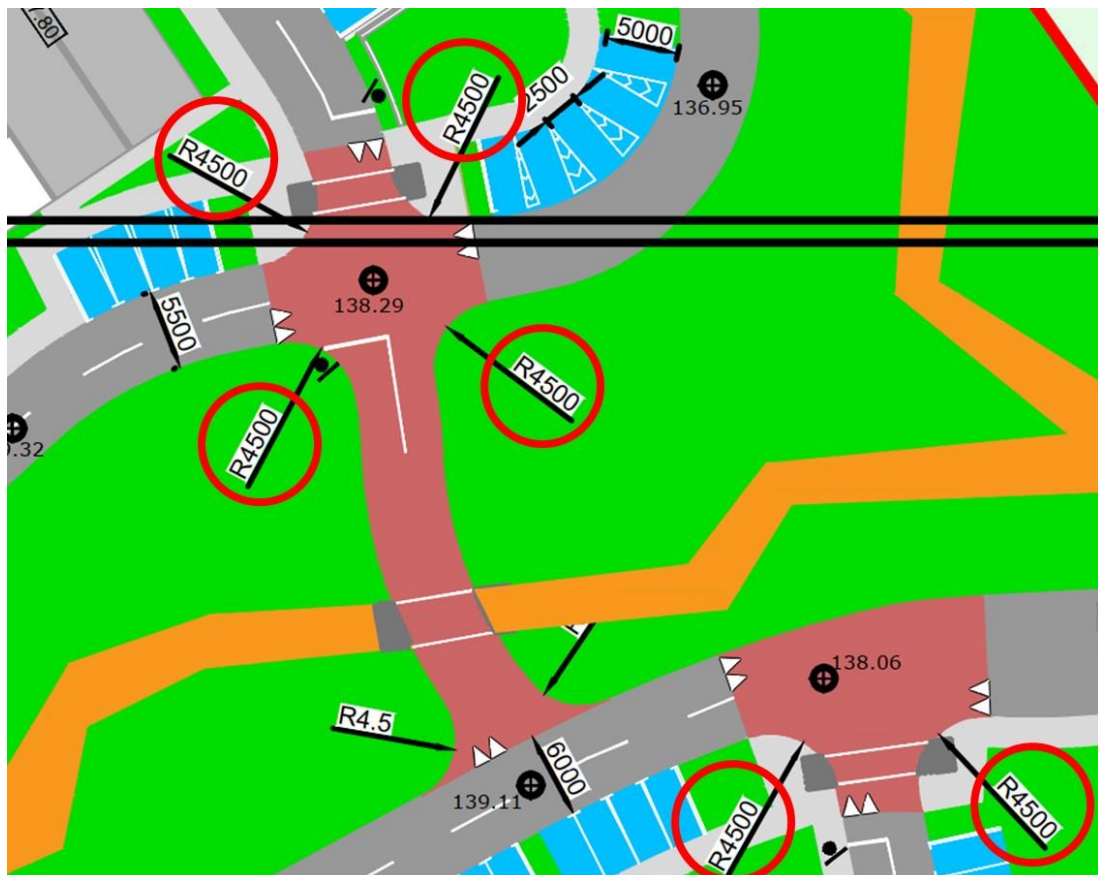
Figure 4.1 – Example Street 11

Throughout Scheme / Dwg no. 900705 GENERAL ROAD LAYOUT

While the majority of junction corner radii within the LRD scheme are 3.0m, there are still some junction radii shown as 4.5m. Large corner radii could lead to excessive vehicle speeds, which could lead to a collision with a pedestrian crossing the road or a vehicle.

DMURS notes that “*where design speeds are low and movements by larger vehicles are infrequent, such as on Local streets, a maximum corner radii of 1-3m should be applied*”. All the roads within the LRD are Local Streets.

Where the LRD connects into the external road network, such as the junctions on the Enniskerry Road, the Glenamuck Road, and the Glenamuck Road Distribution Road, the corner radii can be increased.

The corner radii at the junction should be reduced to accord with DMURS.

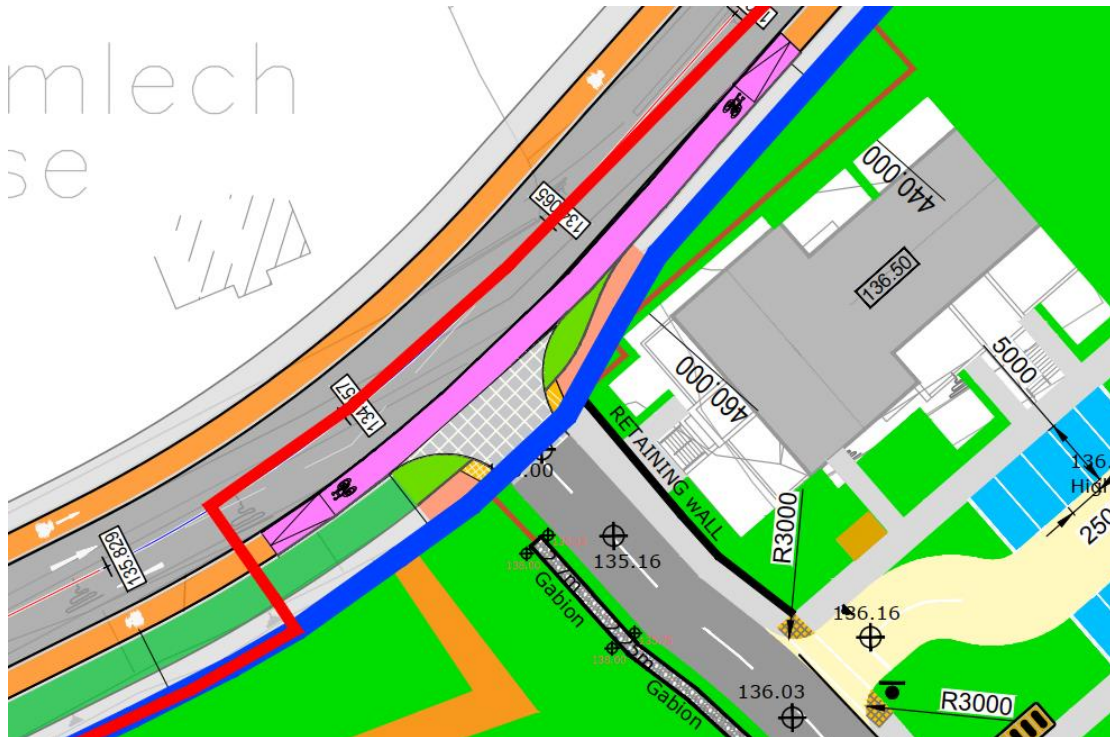
Figure 5.1 – Glenamuck Road Access

Glenamuck Road Junction / Dwg no. L1_100_GENERAL ARRANGEMENT PLAN

The Cycle Manual notes that there are a number of different layouts which can be adopted where cycle tracks cross the mouth of side roads at priority junctions, including those that are fully set back, partially set back, or have no set back, but that the choice is will depend on a number of factors including the available space and the road function and context.

The proposed layout shows a scheme with no set back, of which there are two options in the Cycle Manual. However, the preferred option arrangement is that cycle facilities are fully set back 5m from the road edge as it has a number of advantages, including improving the conflict angle so motorists have better visibility of crossing cyclists and cyclists are kept out of blind spots.

The cycle tracks should be set back 5m at the priority junction, as per Cycle Manul design guidance.

3.3	Y	Y		
3.4	Y	Y		
3.5	Y	Y	the location of lighting will be reviewed and changed where required.	Y
3.6	Y	Y		
3.7	Y	Y		
3.8	Y	Y		
4.1	Y	Y		
5.1	Y	N	Cycle track is designed in accordance with the Cycle Design Manual. As noted there are a number of options for priority junctions. The design shown is the CDM TL403 - Standard cycle track crossing side road with priority – no -set back. As noted in CDM 4.3.3.1 “Where cycle tracks cross the mouth of side roads at priority	Y

junctions, there are a number of different layouts which can be adopted. The choice of layout will likely depend on a number of factors including the available space and the road function and context. " TL403 was chosen due to space constraints and level defences between Glenamuck Rd and site entrance that dictated the design chosen.	
5.2	Y	Y		
6.1	Y	Y		
6.2	Y	Y		
6.3	Y	Y		
6.4	Y	Y		
6.5	Y	Y		
7.1	Y	Y	The location of the crossing of the GLDR to connect the two site will need to be discussed and agreed with the GDRS team. Upon agreement the path and crossing will be provided by the client.	Y
7.2	Y	Y		
7.3	Y	Y

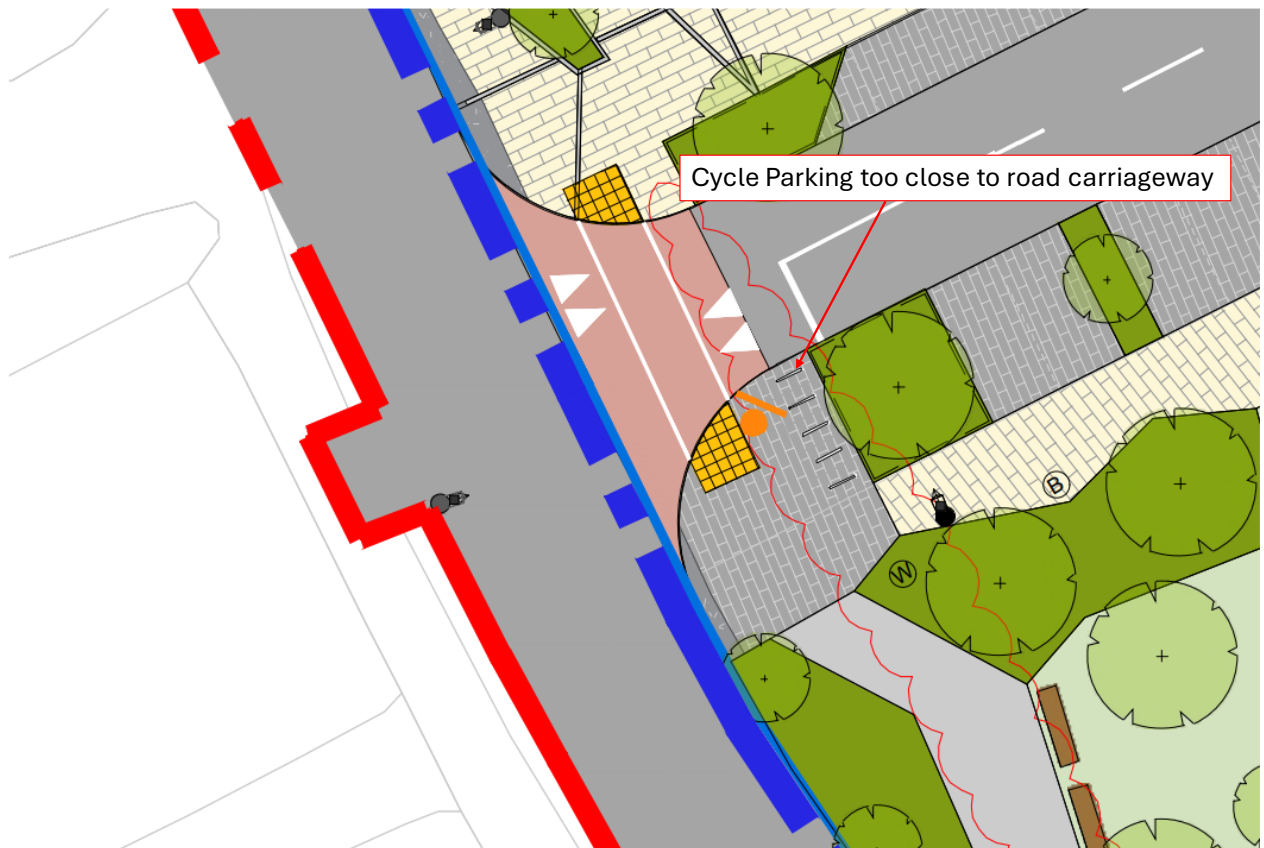
Figure 5.2 – Enniskerry Road Access

Enniskerry Road Junction / Dwg no. L1_100_GENERAL ARRANGEMENT PLAN

The last cycle parking space is located too close to the road carriageway. There is a risk that a pedestrian will have to step out onto the road carriageway when locking or unlocking their bike, putting them at risk with a collision with a passing vehicle.

The cycle parking space should be relocated.

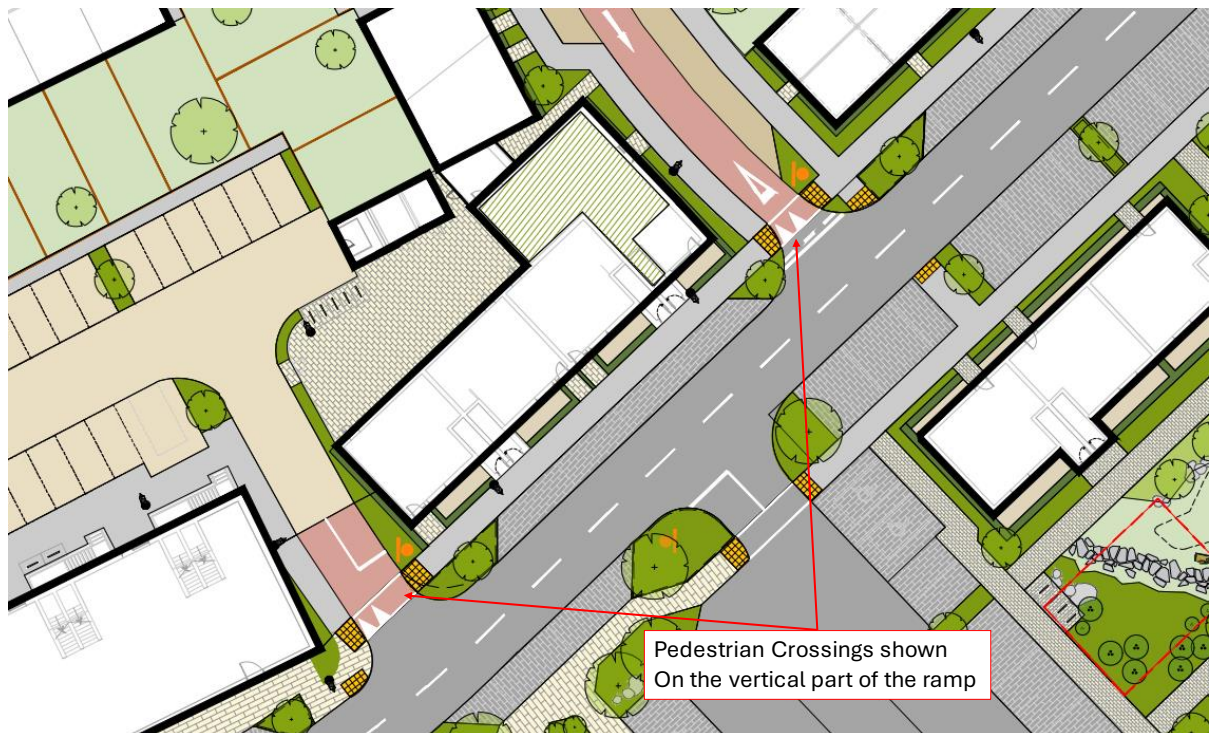
Figure 6.1 – Proposed Pedestrian Crossings

Proposed Pedestrian Crossings / Dwg no. L1_100_GENERAL ARRANGEMENT PLAN

The pedestrian crossings are shown on the vertical part of the ramps. This could lead to pedestrians tripping or falling as a change in slope is not anticipated.

The proposed ramps should be brought forward so that pedestrians are crossing on the flat part of the ramp.

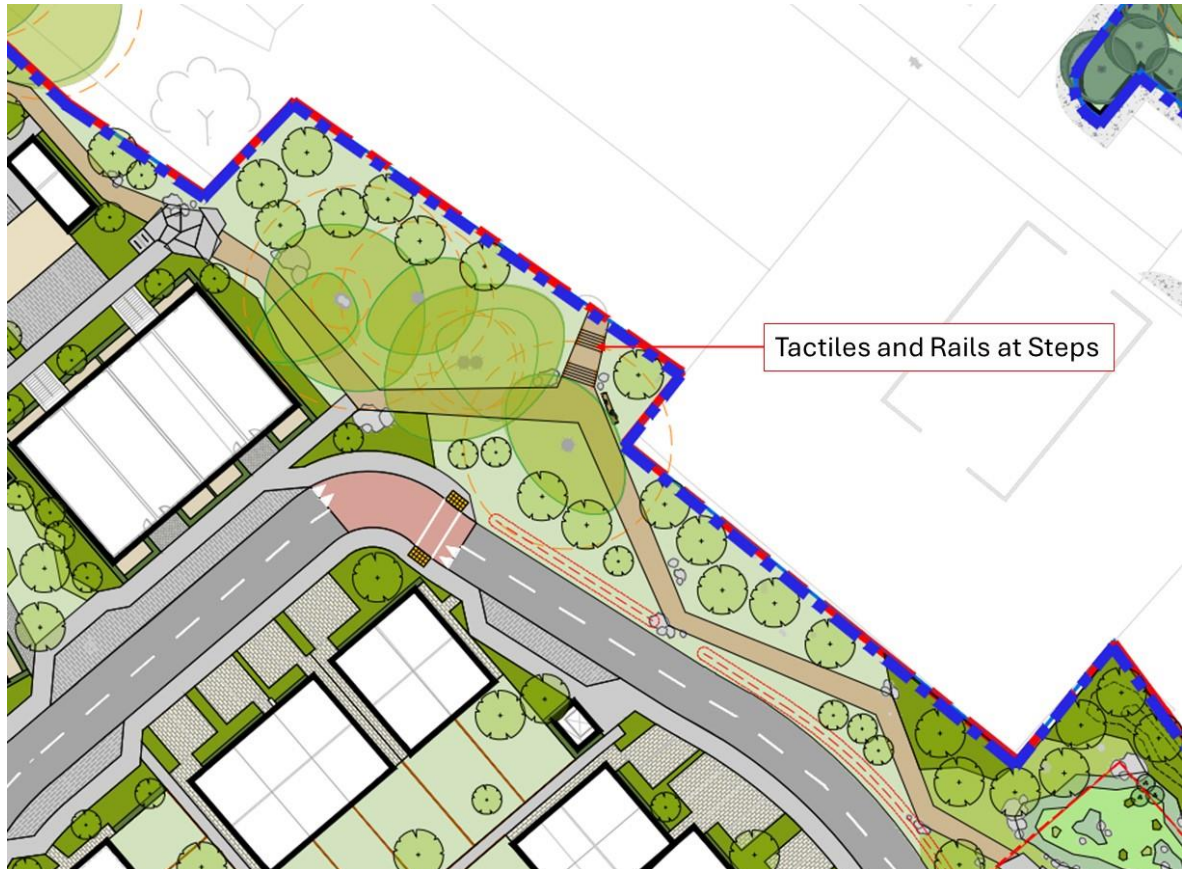
Figure 6.2 – Steps to Adjoining Site

Steps into Adjoining Site / Dwg no. L1_100_GENERAL ARRANGEMENT PLAN

It appears that that steps are provided to an adjacent site. Steps without tactiles or railings could lead to trips or falls.

Appropriate tactile paving and rails should be provided at all pedestrian steps throughout the scheme.

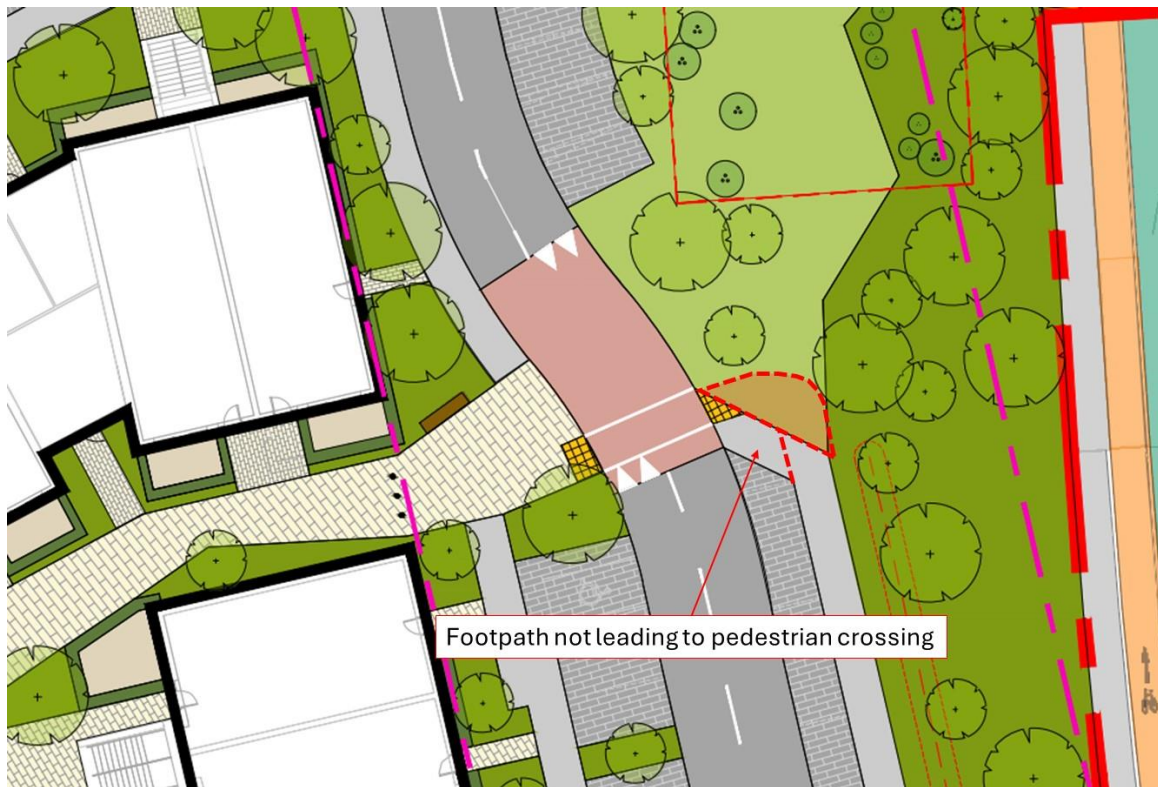
Figure 6.3 – Footpath to pedestrian crossing

Footpath Arrangement / Dwg no. L1_100_GENERAL ARRANGEMENT PLAN

The proposed footpath does not lead to the pedestrian crossing, but to the front of the ramp. This could result in some pedestrians, in particular people using wheelchairs having difficulty crossing at this location.

The footpath should be brought around the back of the tactile paving.

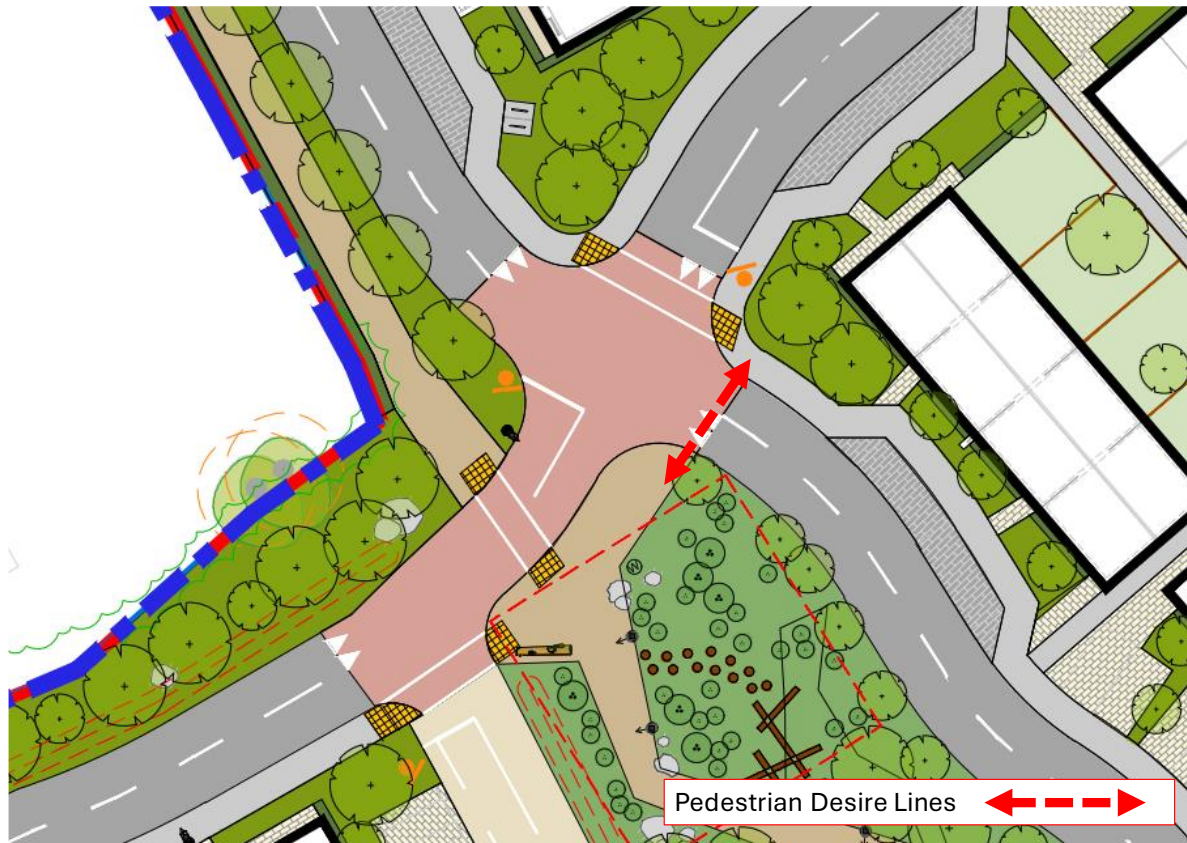
Figure 6.4 – Raised Table

Footpath Arrangement / Dwg no. L1_100_GENERAL ARRANGEMENT PLAN

A desire line will exist between the landscaped area to the south and the residential developments to the north. No crossing point has been proposed on the eastern side of the junction, which will make it more difficult for the visually impaired and those using wheelchairs to cross at this location.

A pedestrian crossing, including a dropped kerb and tactile paving should be provided on the eastern side of the junction.

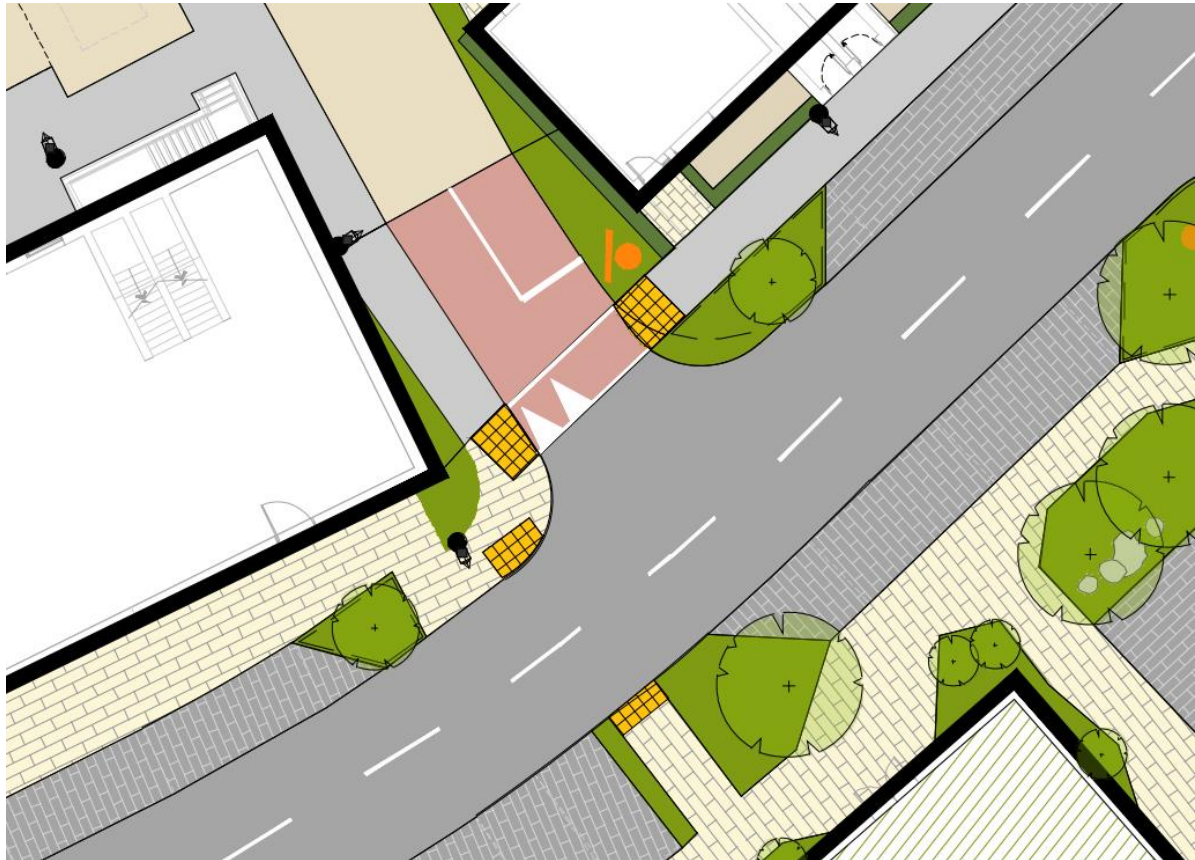
Figure 6.5 – Pedestrian Desire Line on Street 2

Pedestrian Desire Line on Street 2 / Dwg no. 900705 GENERAL ROAD LAYOUT

A landscape strip impedes the pedestrian desire line across the junction. Visually impaired road users may be at risk of a trip.

The pedestrian crossing should be realigned, or the landscape area altered.

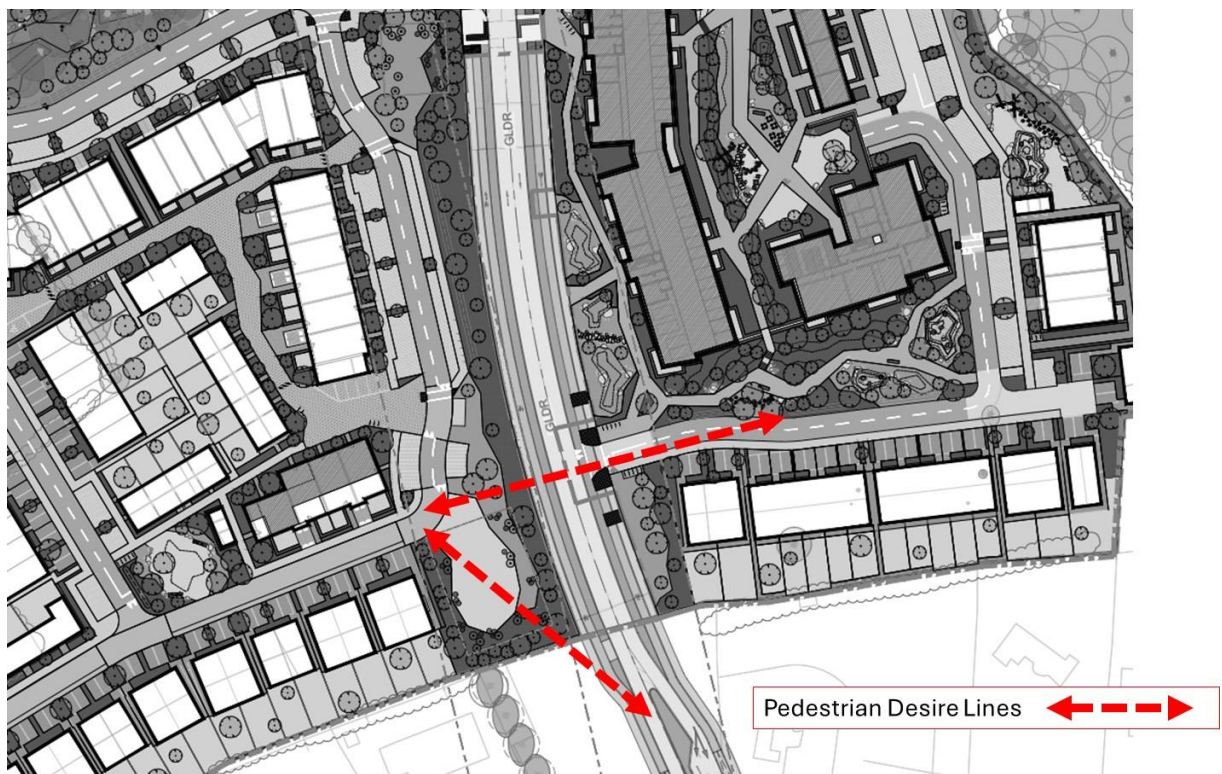
Figure 7.1 – Pedestrian Desire Lines on GLDR

Pedestrian Access at Glenamuck Link Distribution Road / Dwg no. L1_100_GENERAL ARRANGEMENT PLAN

A desire line will exist between the 2no. housing developments across the Glenamuck Link Distribution Road, and for those pedestrians wishing to travel south. No crossing point has been proposed across the GLDR. In addition, pedestrians will likely wish to cross the grassed open space rather than using the longer proposed footpath at the entrance/exit to the north. A lack of hard standing on the desire line could lead to slips and falls in the grassed areas (particularly in winter).

It is recommended that an appropriate safe crossing point be provided, including a footpath connection on the desire line.

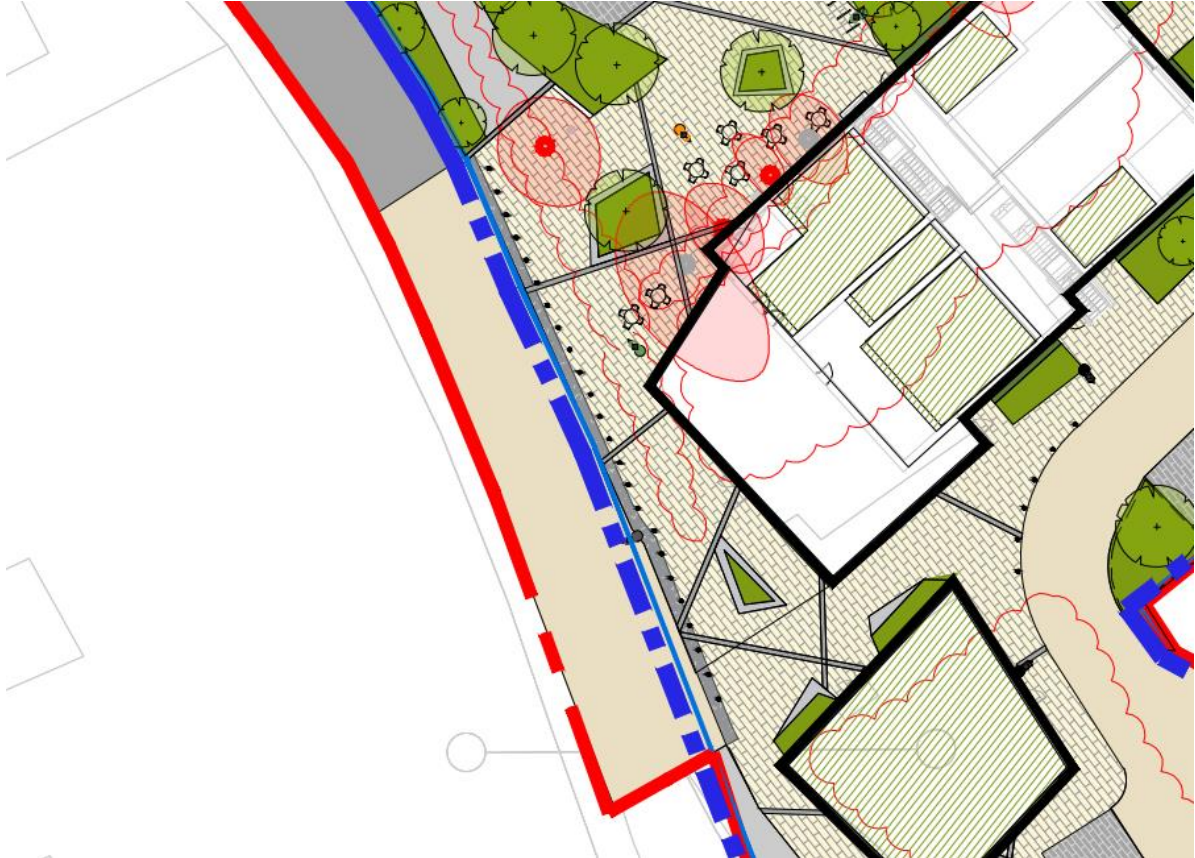
Figure 7.3 – Pedestrian Plaza beside the Enniskerry Road

Southern Plaza / Dwg no. L1_100_GENERAL ARRANGEMENT PLAN

It is unclear what is proposed on the road carriageway beside the pedestrian plaza.

A raised table should be provided to ensure slower speeds passed the pedestrian plaza.
Sharks teeth to be provided etc.
