Arborist Associates Ltd.

An Arboricultural Assessment of the Tree Vegetation on a Development site at 'Wayside', Enniskerry Road and Glenamuck Road, Kilternan, Dublin 18. (Stage 3 of the LRD Application)

Prepared for: Liscove Limited.

Date: 17th June 2024

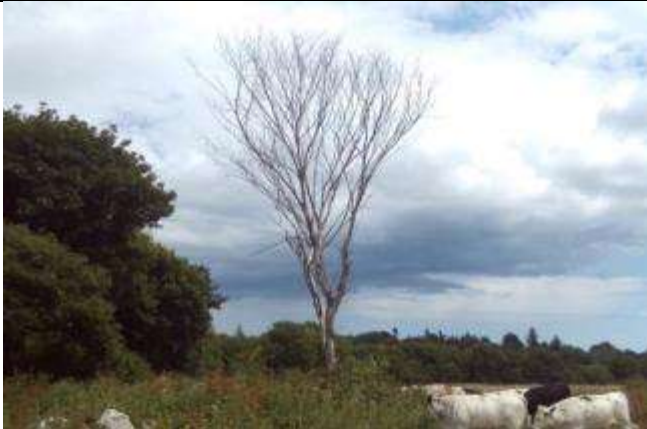
Hedge No.3	Hawthorn <i>Crataegus monogyna</i> Hazel <i>Corylus avellana</i> Elder <i>Ulmus glabra</i> Blackthorn <i>Prunus spinosa</i> Bramble <i>Ulmus glabra</i> Ash <i>Fraxinus excelsior</i>	<p>It is dog-legged in shape and extends to the north-east corner of the site area and cordons off a linear woodland belt from the site area.</p> <p>It is of mature age class in fair condition physiologically and structurally. It is growing on a clay/stone back and the hedge and scrub species such as Bramble and Gorse have been cut back to allow new stock-proof fencing to be constructed.</p> <p>The trees within form part of the outer canopy edge of a larger neighbouring woodland belt. They are of value to the structure and integrity of this woodland belt and this will need to be taken into consideration during management.</p>							Requires no work at the present time.	--	C2

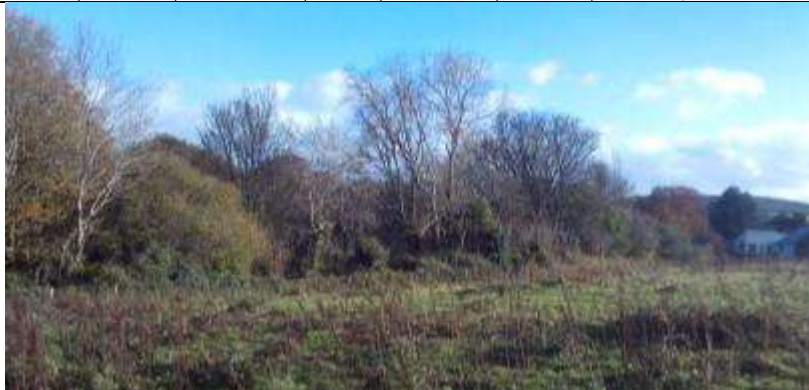
Hedge No.4	Hawthorn <i>Crataegus monogyna</i> Blackthorn <i>Prunus spinosa</i> Sycamore <i>Acer pseudoplatanus</i> Holly <i>ilex aquifolium</i> Elder <i>Sambucus nigra</i> Hazel <i>Corylus avellana</i> Bramble <i>Ulmus glabra</i>	It runs at ninety degrees to Hedge No.3 and forms part of the eastern boundary of this field with the adjoining linear woodland belt. It is of mature age class in fair condition physiologically and structurally. It is growing on a soil/stone bank and consists of clumps of Hawthorn, Blackthorn, Sycamore, Holly, Elder, Hazel, Bramble and Dogrose with Ash ranging in age from seedlings to mature trees. The site side of the hedge line has been cut back, in particular encroaching scrub species, such as Bramble and Gorse and a new stock proof fence has also been constructed on the side site cordoning it off.							Requires no work at the present time.	---	C2

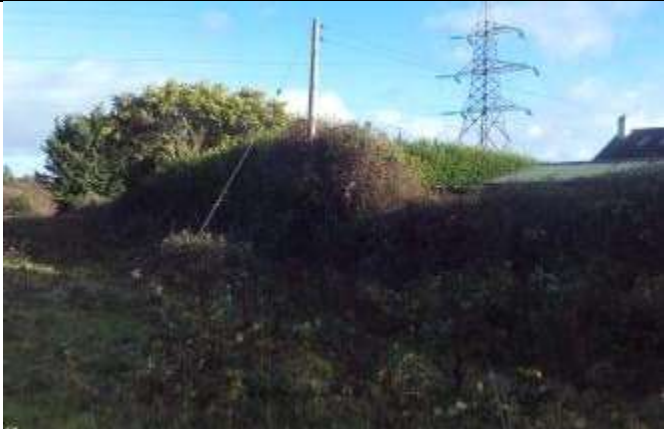
A2	--	A2	--						
Hedge No.7	Leyland Cypress <i>Cupressocypariss leylandii</i> Griselinia <i>Griselinia littoralis</i>	It extends west of Hedge No.6 and is located on the adjoining landside of the boundary fencing. It is a mature hedge in fair/poor condition physiologically and structurally. It has recently been heavily cut back removing a lot of green foliage and it may not respond well to this. It forms a screen barrier between properties. At the eastern end, there is a section of Griselinia which has also been cut back hard. A new stock proof fence has been constructed on the site side.							Management is outside the control of this site area.		C2

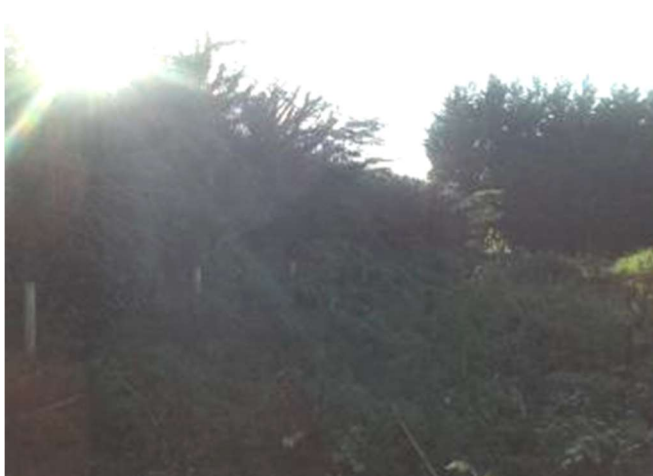
A4	A350	A3	--						
Hedge No.8	Elder <i>Sambucus nigra</i> Hawthorn <i>Crataegus monogyna</i> Bramble <i>Ulmus glabra</i> Dogrose <i>Rosa canina</i> Ash <i>Fraxinus excelsior</i>	It runs at ninety degrees to Tree Belt No. 1 and forms an internal boundary between two fields within the site area. It is of a mature age class in poor condition both physiologically and structurally. It consists of isolated clumps of Elder with some Hawthorn. It would appear to be growing on either side of a stone boundary wall. The bulk of this hedgerow and the encroaching scrub species extending out south have been removed and this has left a small number of trees and isolated hedgerow plants such as Elder and Hawthorn.						A3 -- A4 --	It would benefit from some infill planting to create a more continuous hedge.	---	C2

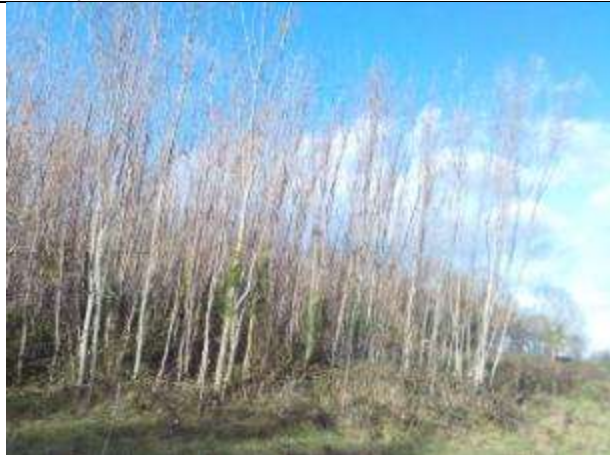
Hedge No.10	Hawthorn <i>Crataegus monogyna</i> Elder <i>Sambucus nigra</i> Gorse <i>Ulex europaeus</i> Bramble <i>Ulmus glabra</i> Dogrose <i>Rosa canina</i> Ash <i>Fraxinus excelsior</i> Sycamore <i>Acer pseudoplatanus</i>	It runs at ninety degrees to Hedge No.8 in an east west direction and extends along the boundary with the old farm yard and the field to the north. It is of a mature age class in fair condition both physiologically and structurally. It is growing on top of a dry-stone wall and is not a continuous hedgerow with sections missing throughout. It consists of clumps of Hawthorn, Elder, and Gorse with large infill area of Bramble and Dogrose. Ash and Sycamore ranging in age from seedlings to mature trees form part of the bulking and upper canopy. A section of the hedgerow has been removed at the east end as part of site clearance works and the north side has been trimmed in to contain encroachment out onto the field. A new fence has been erected to cordon off this hedge from the field to the north. <table><tr><td>AV4</td><td>--</td><td>AV5</td><td>--</td></tr></table> The following trees are located within hedge No.10.						AV4	--	AV5	--	Carry out infill planting to bulk up and rejuvenate this hedge. Trim in encroaching hedge vegetation to contain hedge width.	---	C2
AV4	--	AV5	--

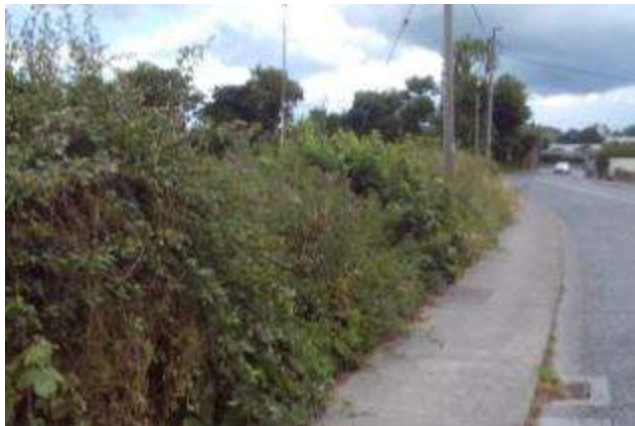
</div> <div><table><tr><td>A1.8</td><td>--</td><td>A3</td><td>--</td></tr></table></div> The following Tree is located within Hedge No.11.							A1.8	--	A3	--	Continue present maintenance. Improve structure of hedge by adding in other hedge species.	C2
A1.8	--	A3	--											
890	Ash <i>Fraxinus excelsior</i>	10	440/ 330	3N 4S 3E 3W	2	Mature	Poor	Poor It forms a twin-stemmed tree from low down with an acute union formation between stems. Heavy Ivy cover on the main trunk is extending up into its crown increasing its crowns wind sail. This tree has suffered substantial root	I would recommend its removal as part of management.	<10	U
